TECHNICAL ASSISTANCE FOR RENOVATION OF MDR-TB WARD AT MULAGO HOSPITAL

Kampala, Uganda

November 9 - 12 2011

ENVIRONMENTAL/ENGINEERING REPORT

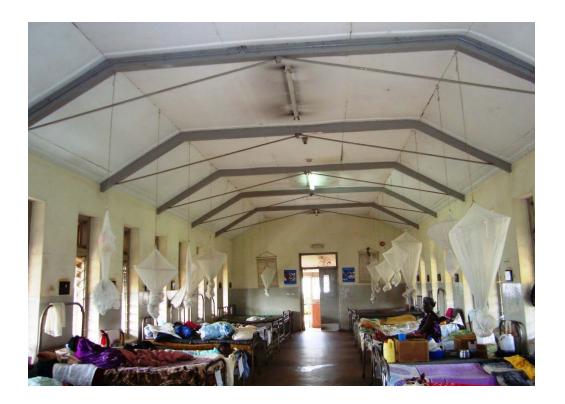
Interior of female ward

There is no need of ceiling in the male ward; the exposed wooden structural truss and wooden ceiling surface after surface preparation can be varnish coated to bring out its natural beauty. For the female ward replace ceiling materials.

Provide also metal louvers of size 20 x 20cm on every bay between the truss elements on the horizontal surface of the ceilings. These are the openings which will help the accumulated hot air to escape to the ridge ventilation above through stack effect.

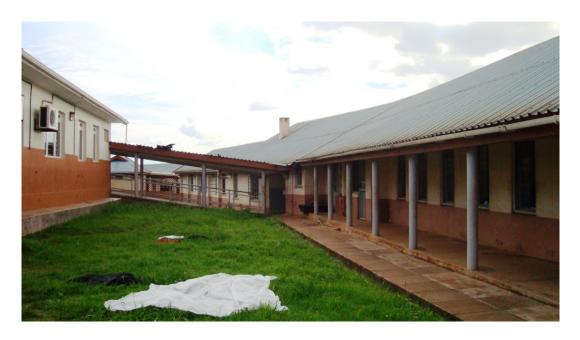
The existing walk way around the Female ward measuring 130cm wide (clear distance) is proposed to serve as a circulation area, but it is smaller than the minimum standard width of 180cm for a one way corridor. Therefore a full 2m wide corridor is planned in addition to the existing corridor for circulation. The existing corridor space will be used for patients' day area-an open shades space which is an extension of their indoor ward rooms. It is preferable that this corridor be covered with the same iron sheet roof material as that used for the existing buildings but with a shallower slope to allow head room in the added open corridors. As a result, 170m2 of ground floor slab will be constructed for the additional external corridor. Part and parcel of this additional circulation area are ramps that are used to reconcile the level difference.

Veiw of the female ward from the interior courtyard

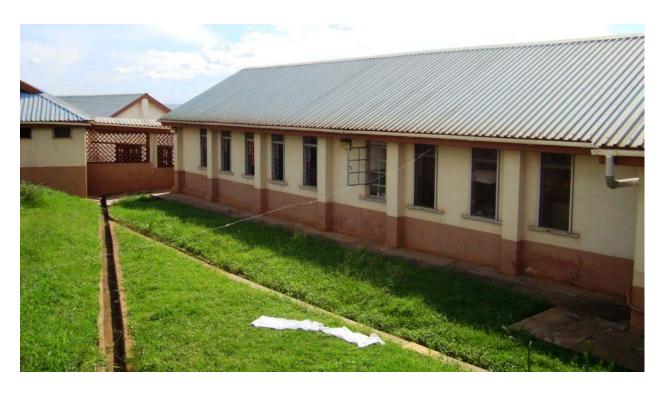
View of male ward from the interior courtyard

Clearstory openings to be of wire meshes to be maintained as they are except for replacing the old wire meshes and upgrading the frames.

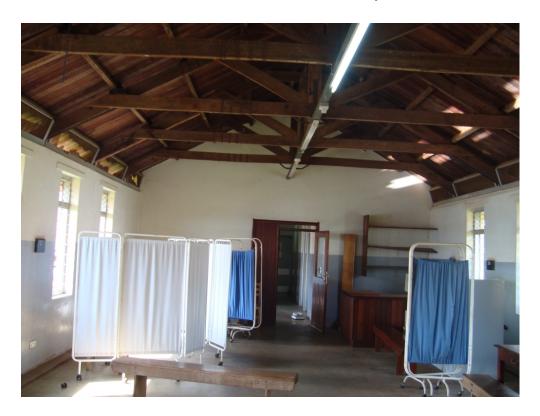
Interior view of male ward

Ridge ventilation running along the entire length of the wards as shown in Annex-II is proposed to create stack effect ventilation. Referring to the existing as built set up the width of the skylight should be 1.45m.

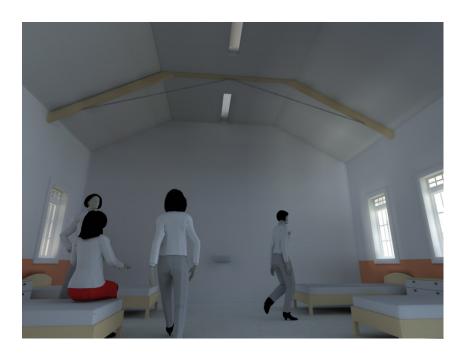
Ceiling louvers proposed inside female ward. These louvers enable ventilation of the wards via raised ridge ventilation

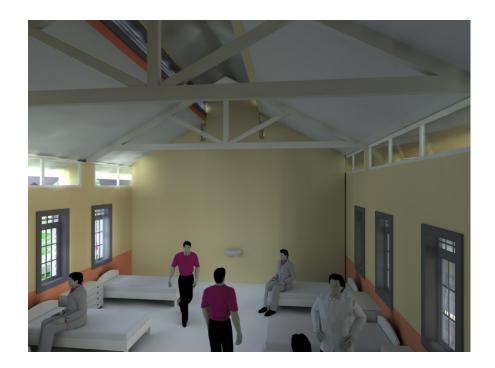
Ridge ventilation proposed inside male ward existing clerestory windows are maintained by replacing the old wire meshes

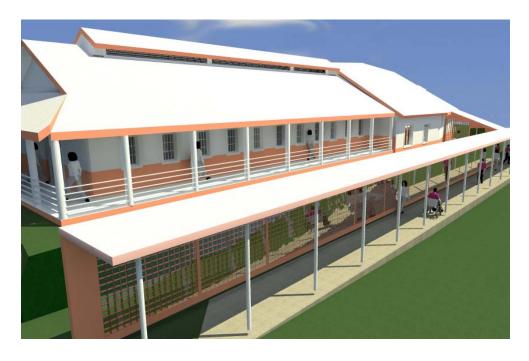
Pompeii wall (air brick wall) to screen the passerby people from the female MDR ward because they are very close at this location

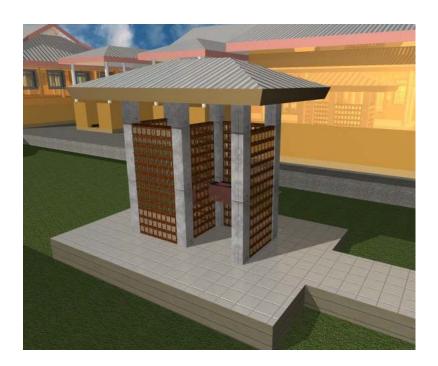
View of sputum booth

Providing new structures of relatives' sheds and sputum booth. Sample sputum booth is
presented. The sputum booth should be placed at minimum of 6m distance from existing
structures and such location is suggested.
